**ENGINEER'S REPORT**  
of the  
**McKEAN RESIDENCE FIRE**

Daryl L. Ebersole, P.E., CFEI

February 5, 2013

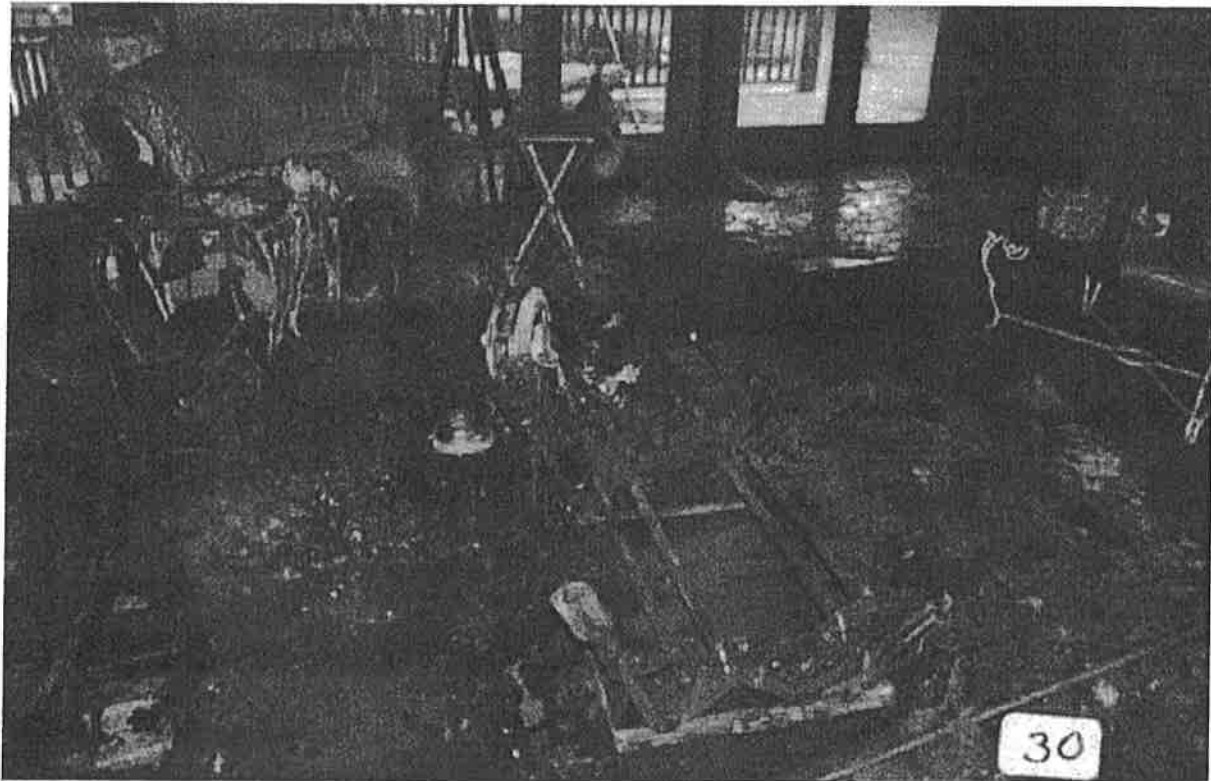
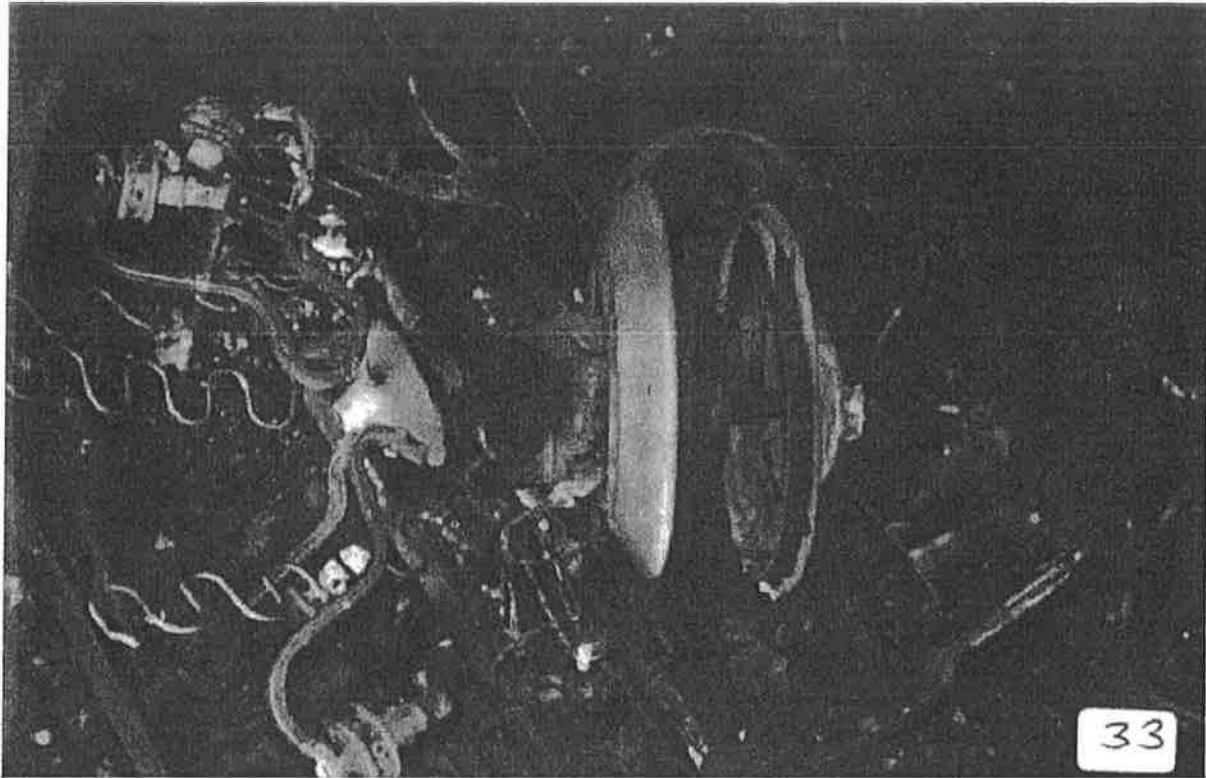
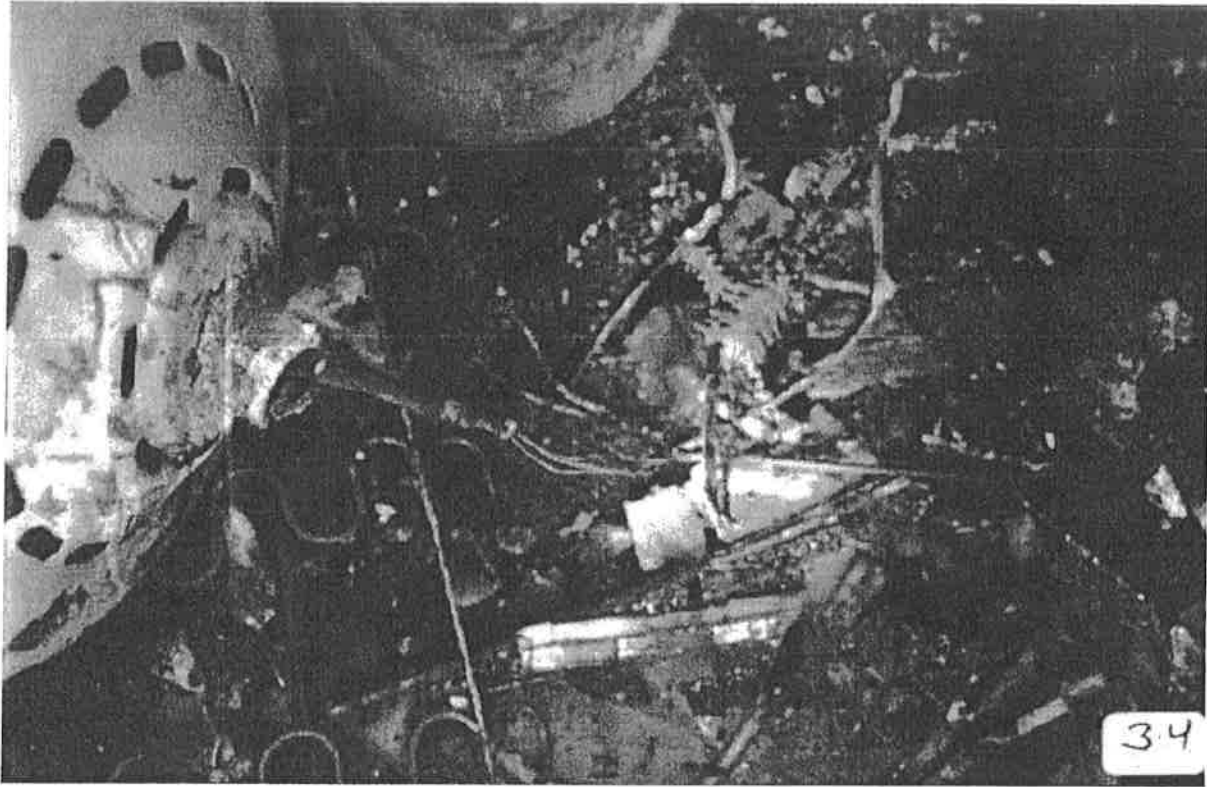
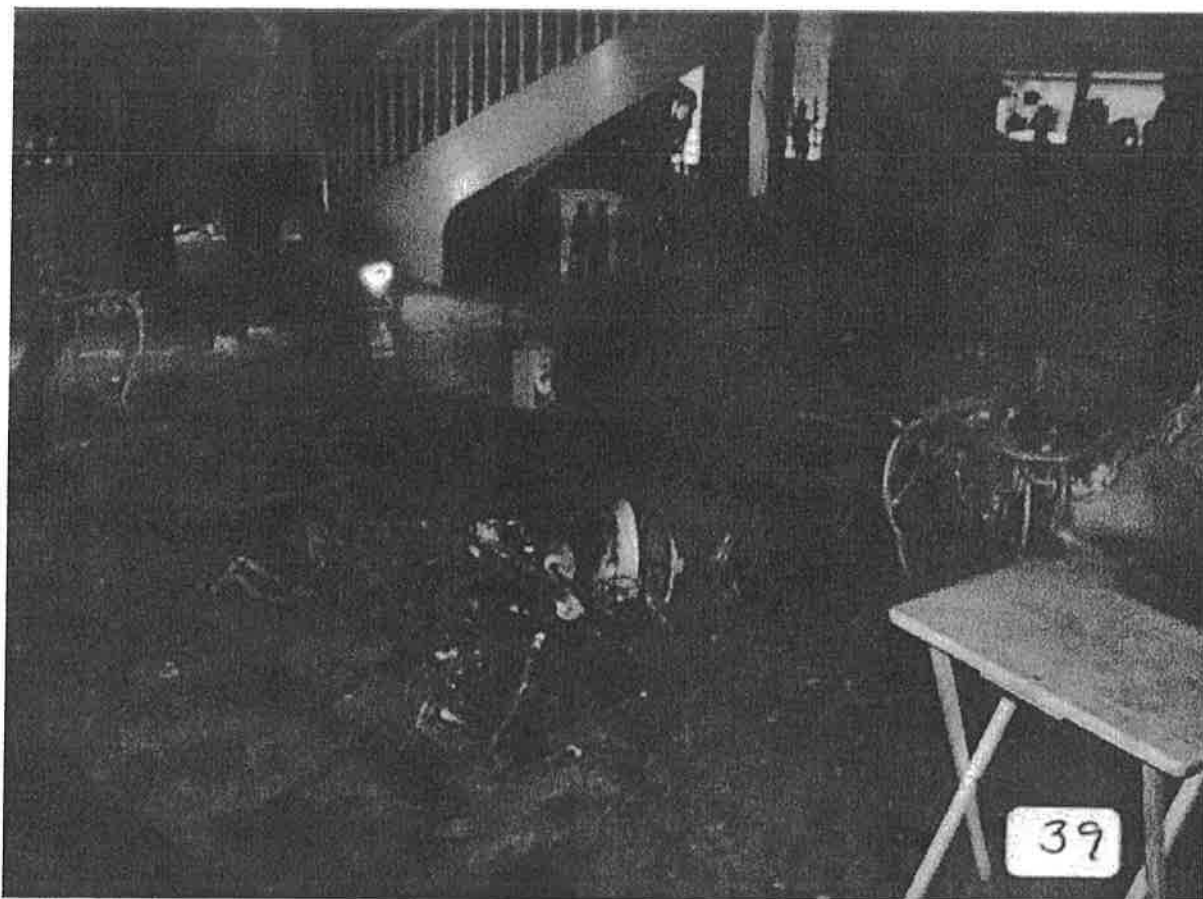
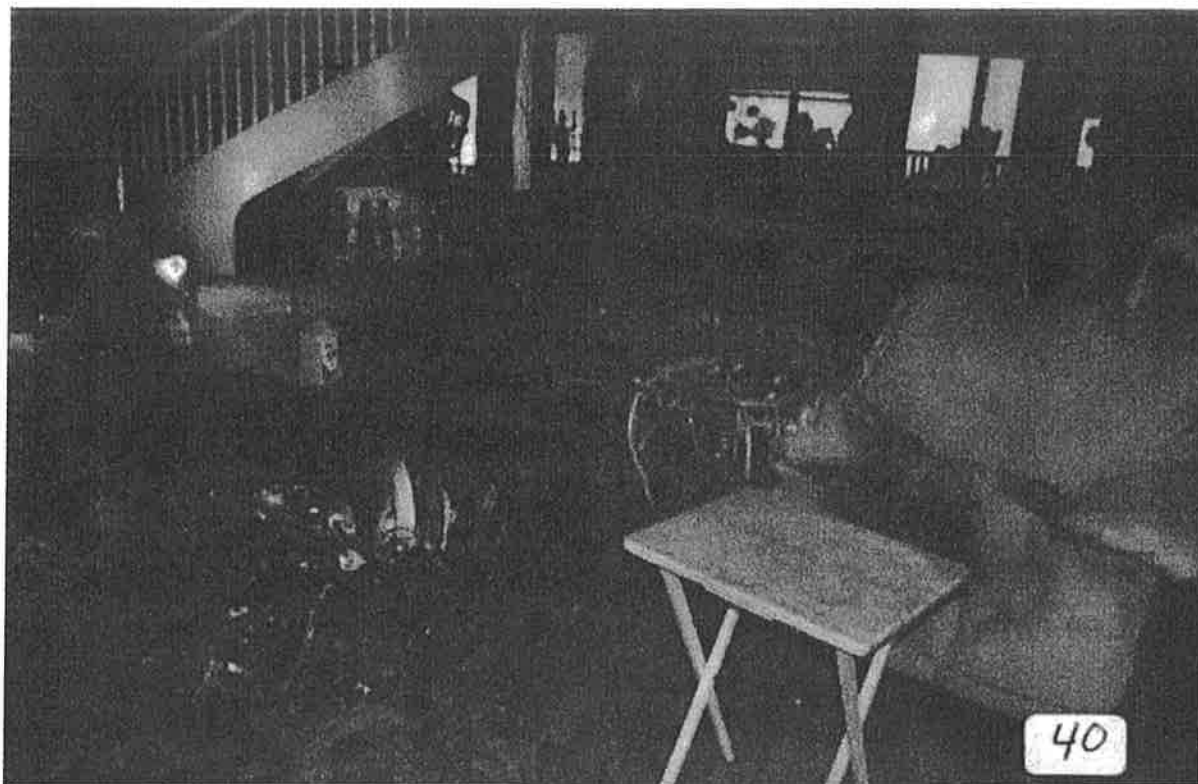
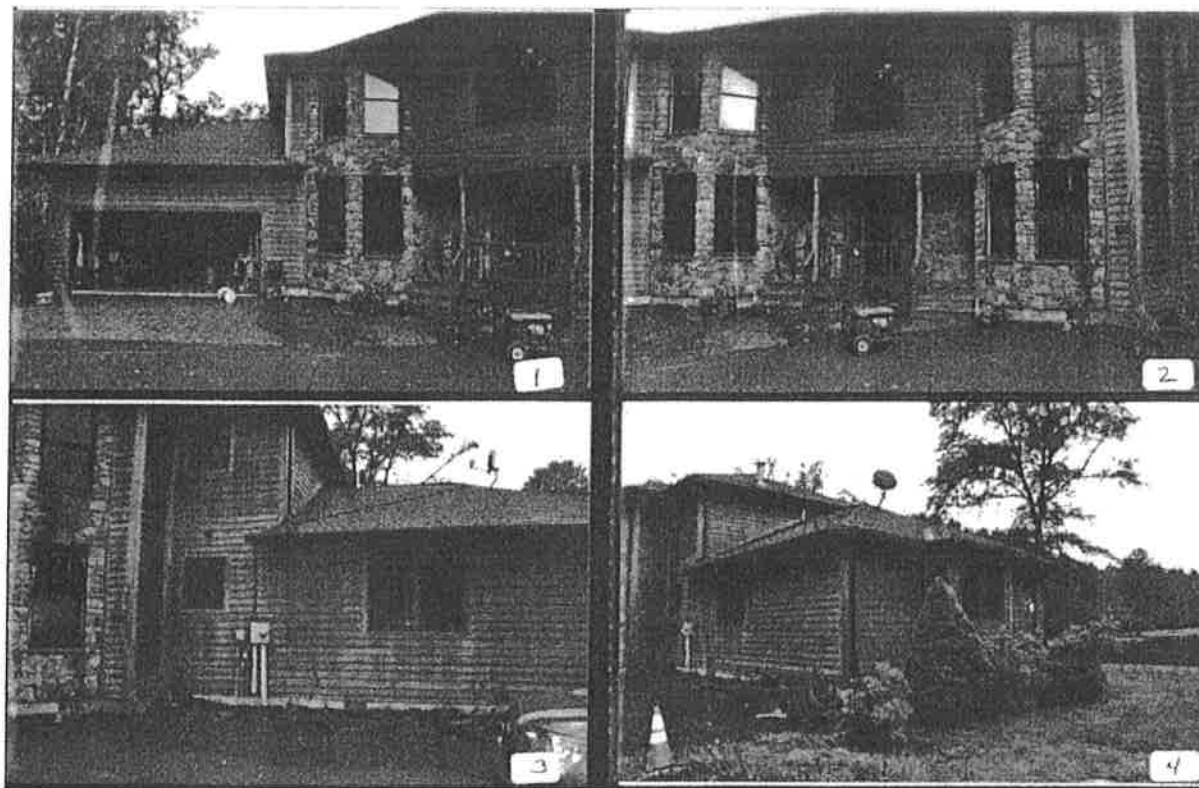
1. Burned debris and soot are evident in numerous photographs at various locations in the house.
2. Site photographs are shown in **Figures 1 - 7.**

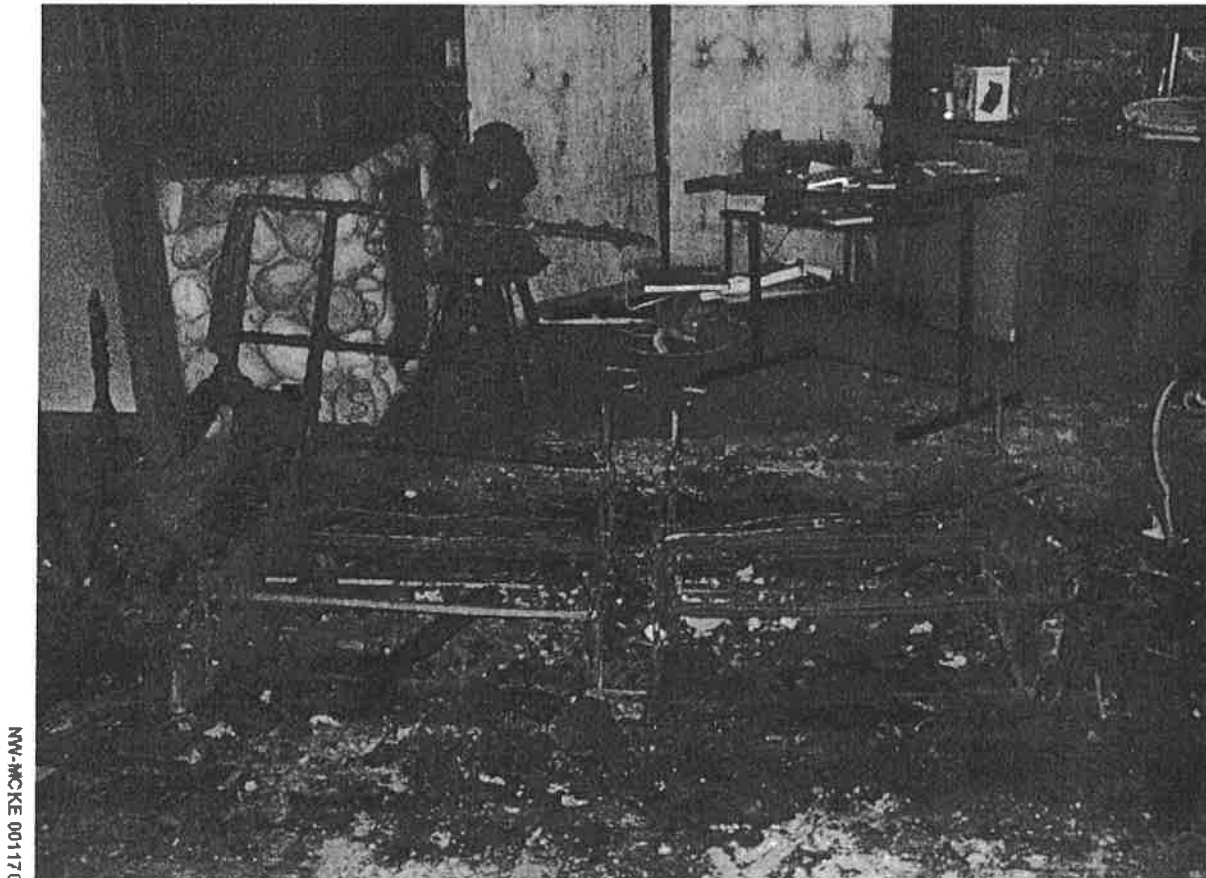
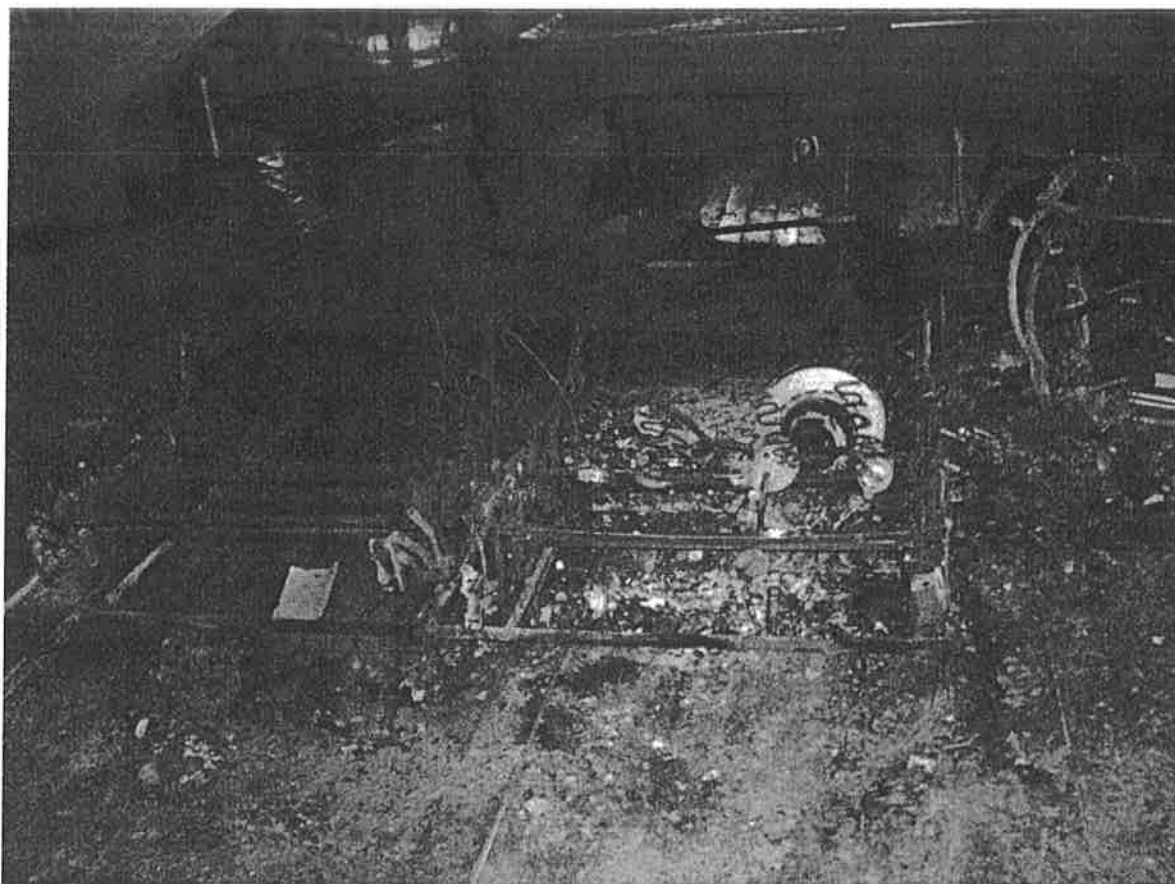
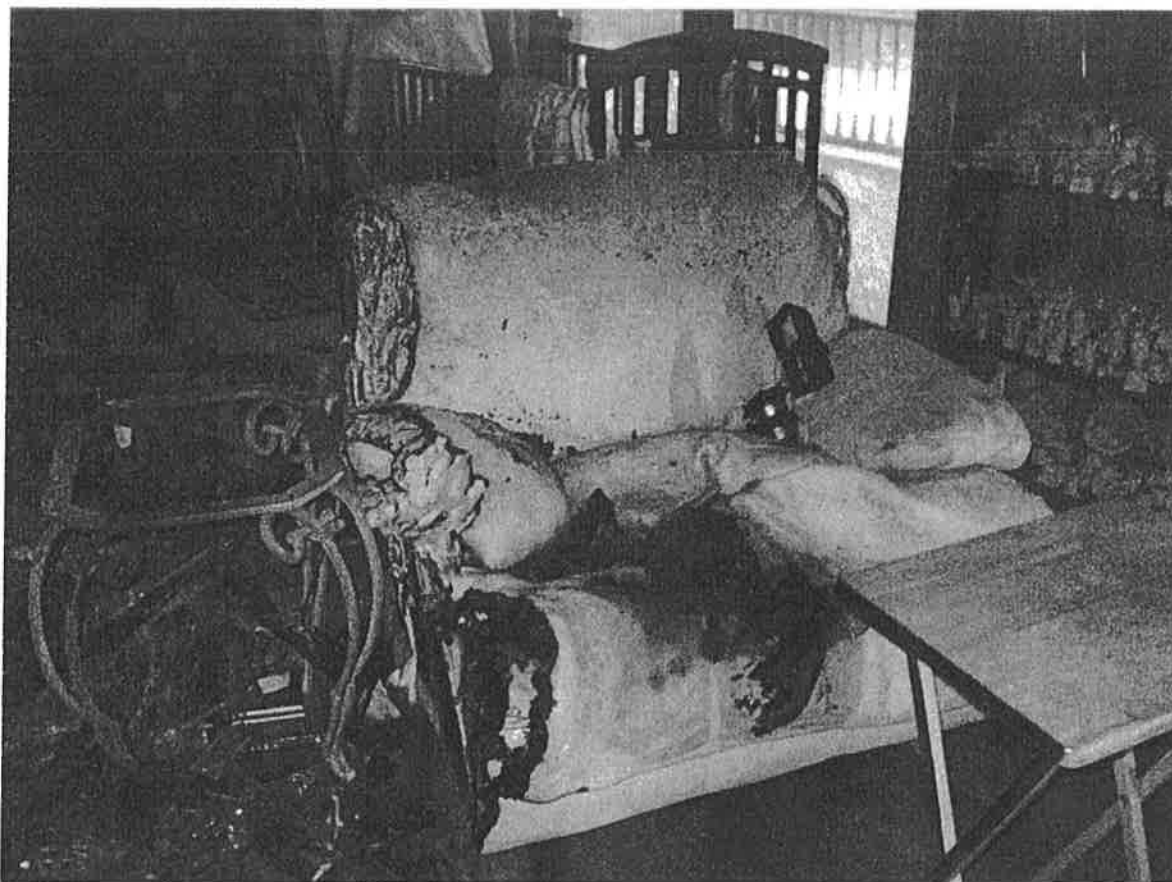
1. Burned debris and soot are evident in numerous photographs at various locations in the house.
2. Site photographs are shown in **Figures 8 - 10**.

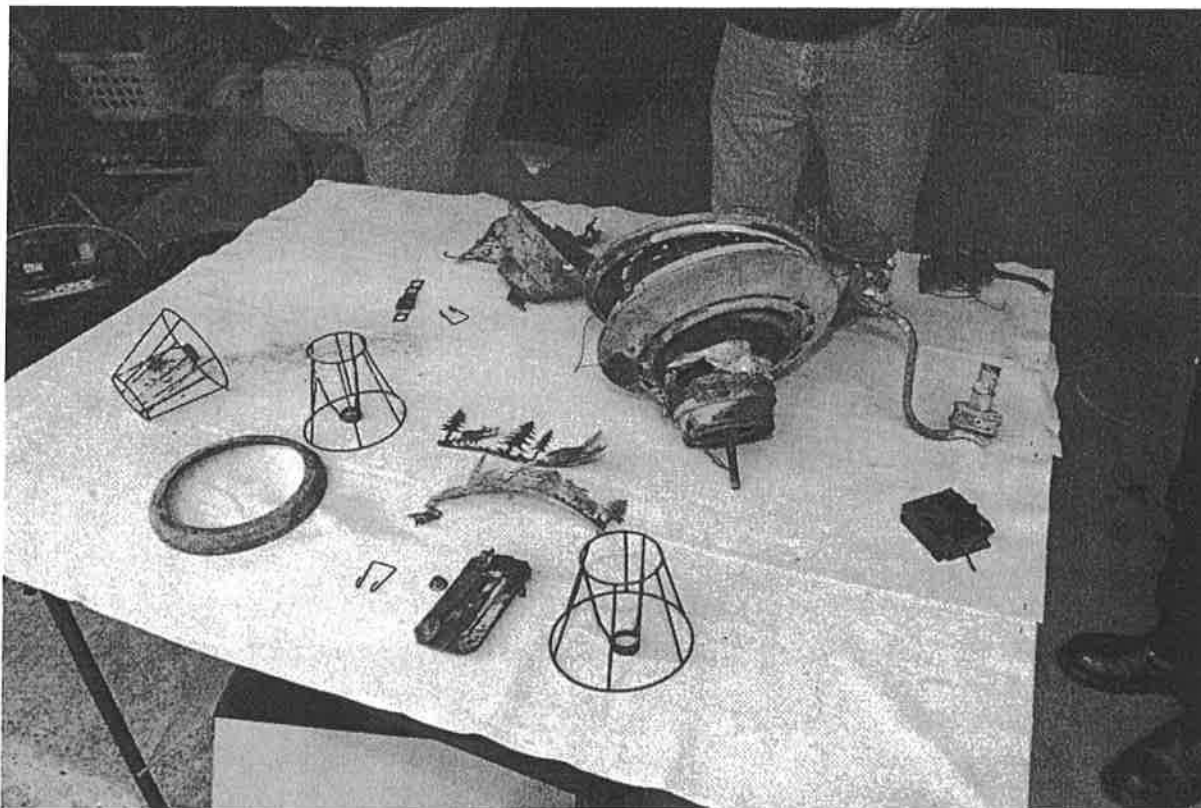
**Figure 11**

1. Mr. Jones brought the ceiling fan/light parts that were retrieved from the fire back to the site of the fire for a destructive examination. **See Figure 11**

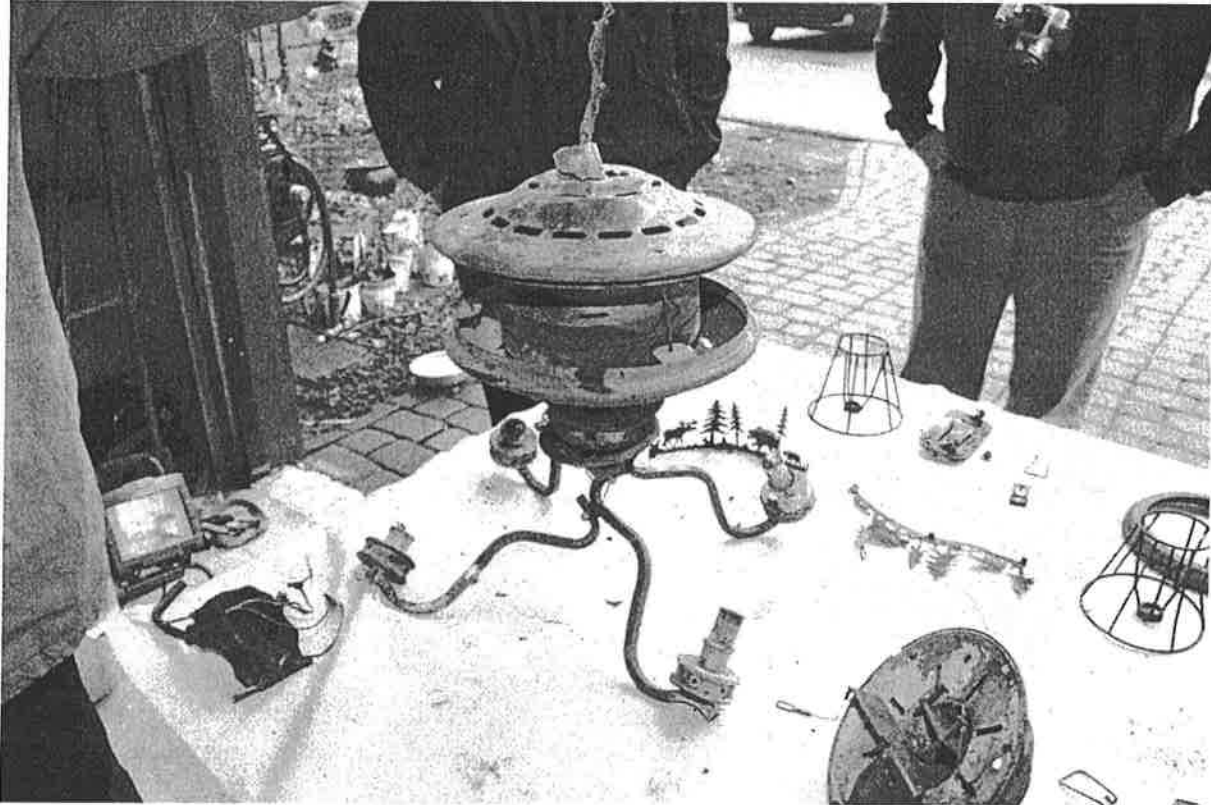
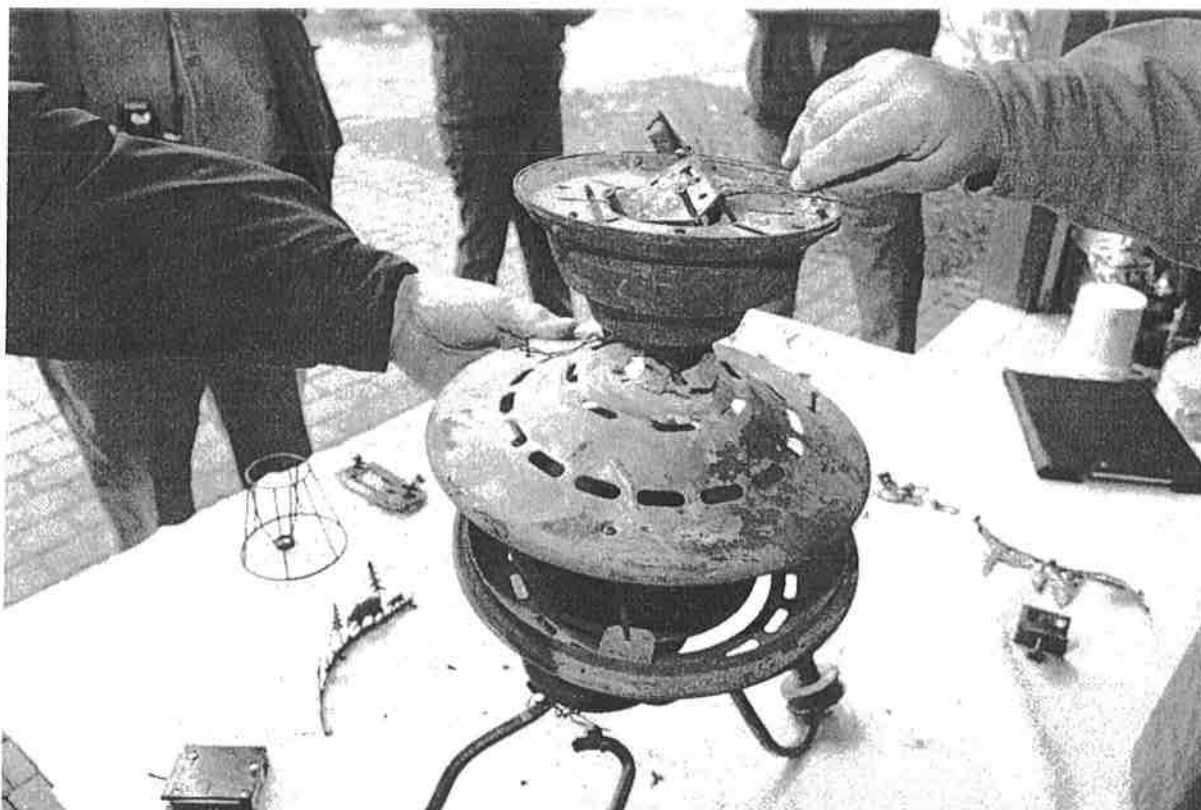
2. The pieces were placed in an orientation approximately like would have been expected of an assembled ceiling fan/light. See **Figures 12 - 13**

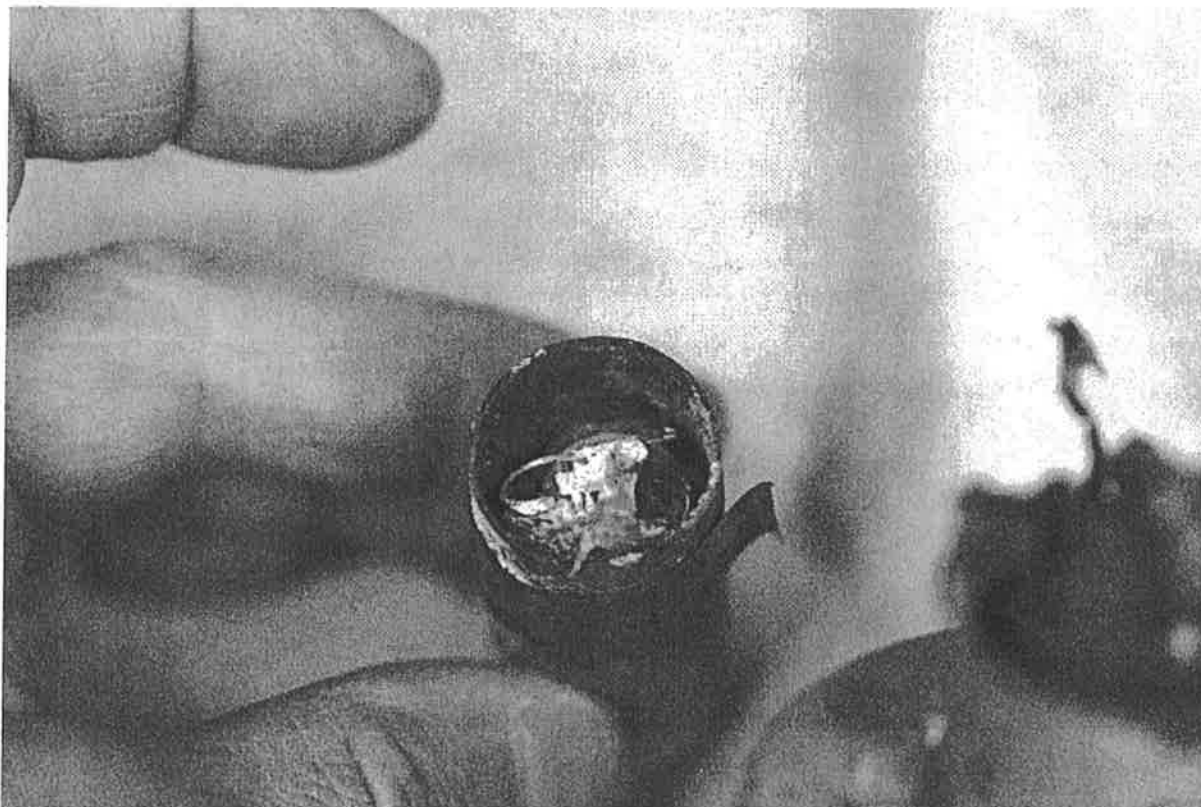
4. There is evidence of melted and solidified metal in the area of the lamp holders. See **Figures 14 - 15**

There is melted and resolidified metal in the area of the lamp holders. There is melted and resolidified copper on the wiring in the area of the switches that resulted from arcing. There is damage to the motor windings which lessens as distance increases from the laminated core. Insulation of wiring that is compromised and allows current to flow in unintended paths results in arcing. Arcing is a well known cause of fires. Motor windings increase in temperature when current flows through them. Increasing mechanical load due to circumstances including bearing failure can cause windings to overheat. Overheated motor windings can cause temperatures to rise to the point of igniting nearby materials. Overheated or burning parts from a ceiling fan/light can ignite things that they fall upon. The evidence of the ceiling fan/light is consistent with being a cause of a fire. The ceiling fan/light could not be ruled out as a cause of the fire.

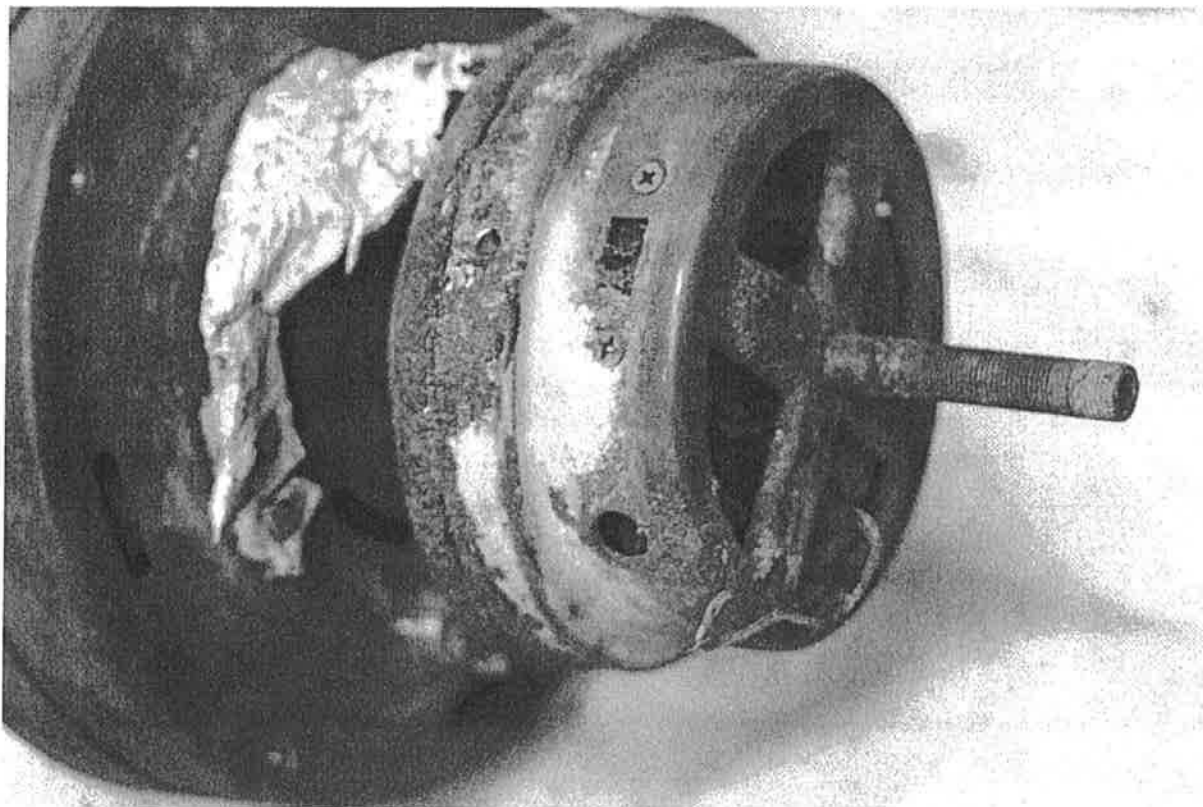
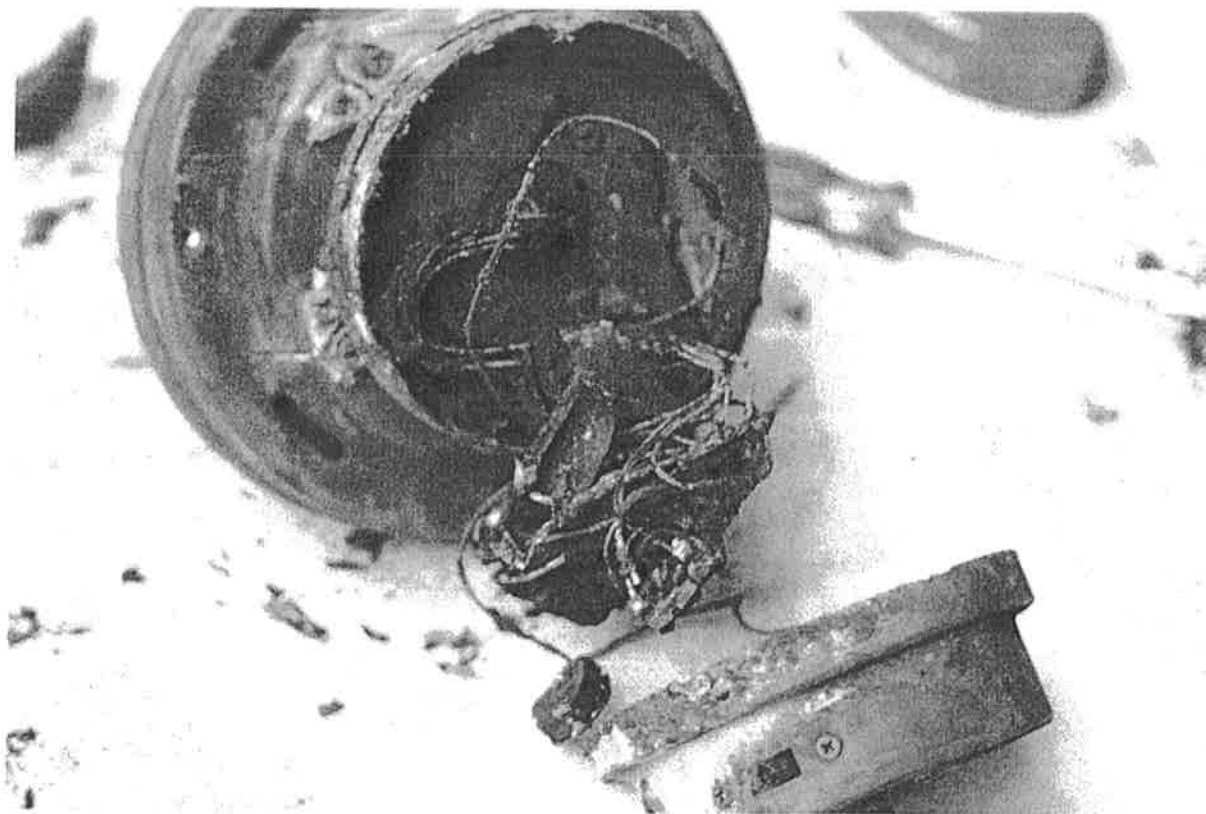
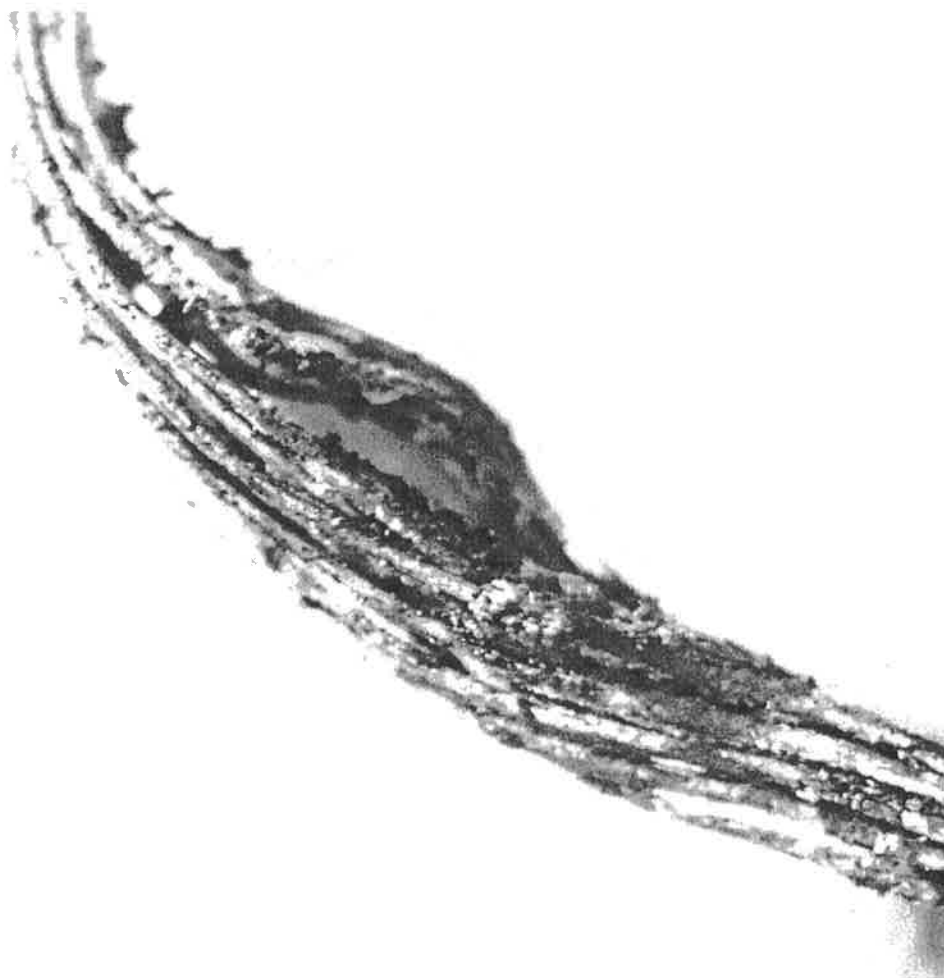
5. The switch housing was opened. Inside the switch housing there is evidence of melted and resolidified copper wiring. See Figures 16 – 19 for examples

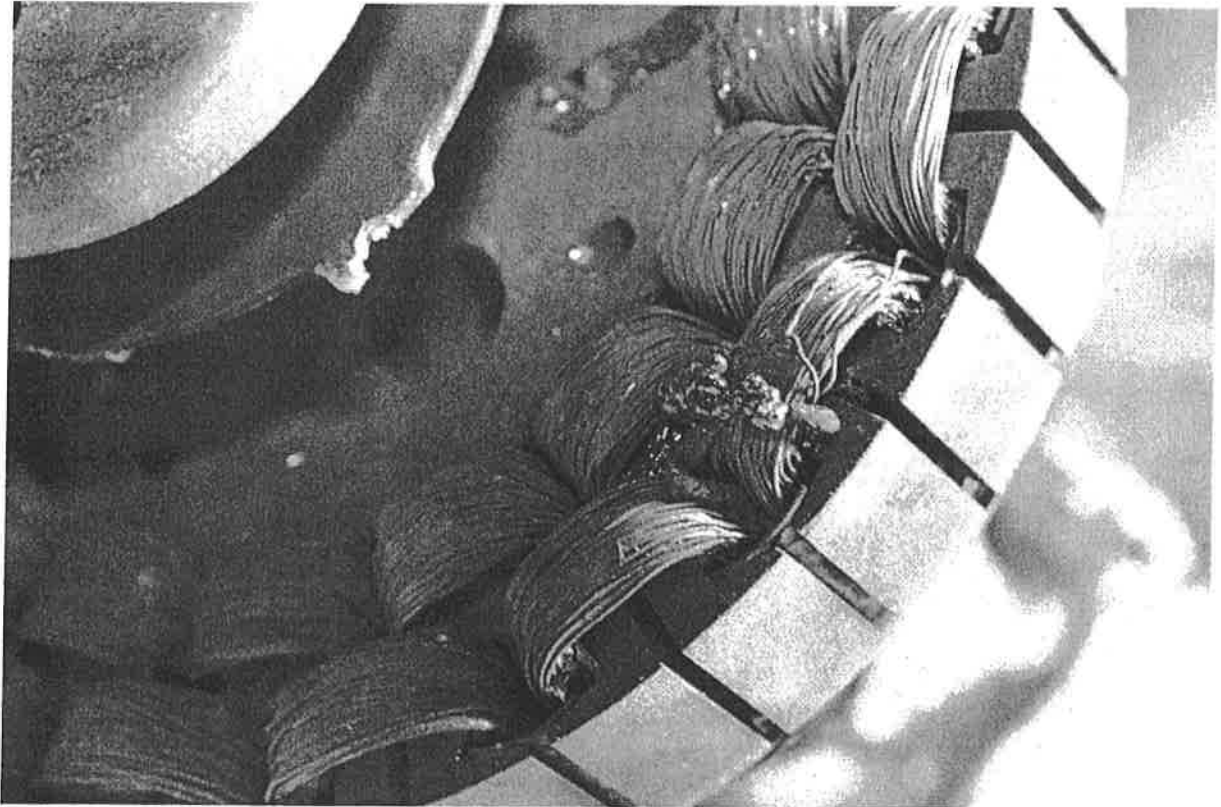
**Figure 20**

6. The motor housing was opened to expose the motor windings. There are melted materials

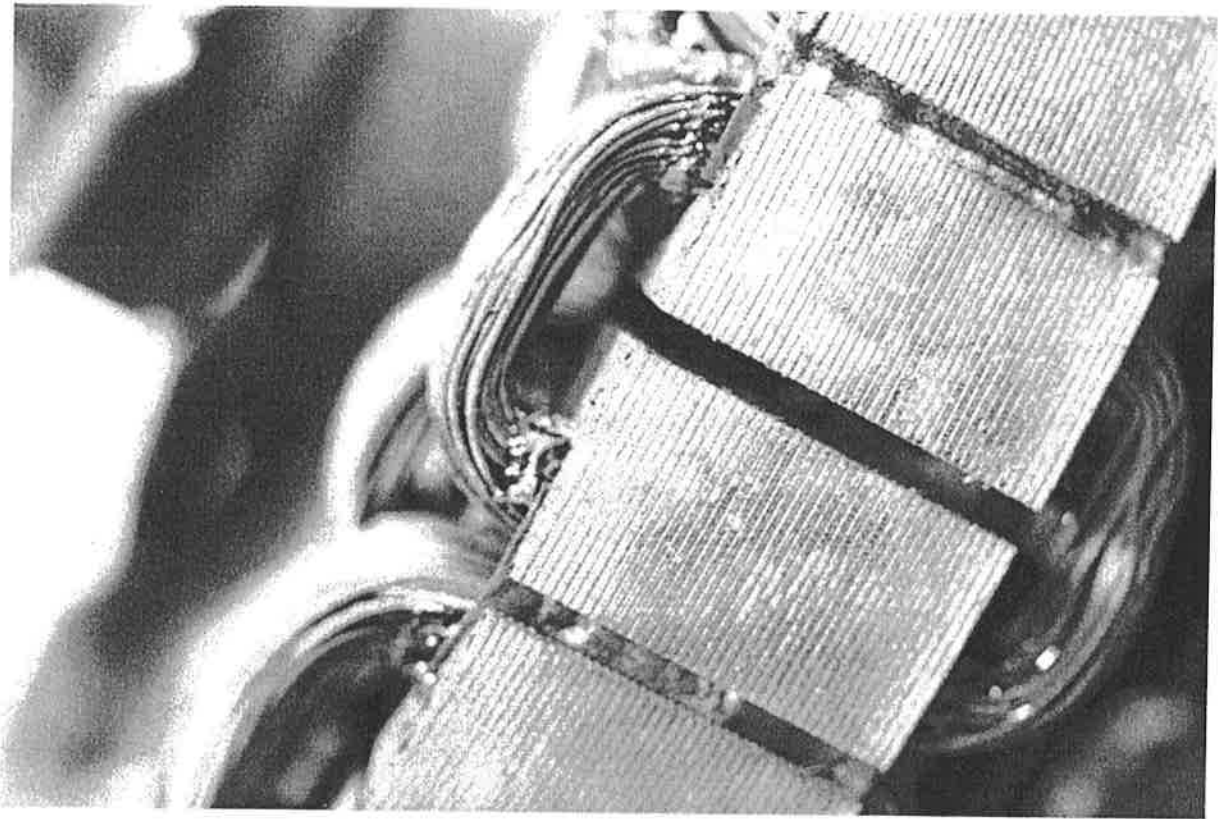
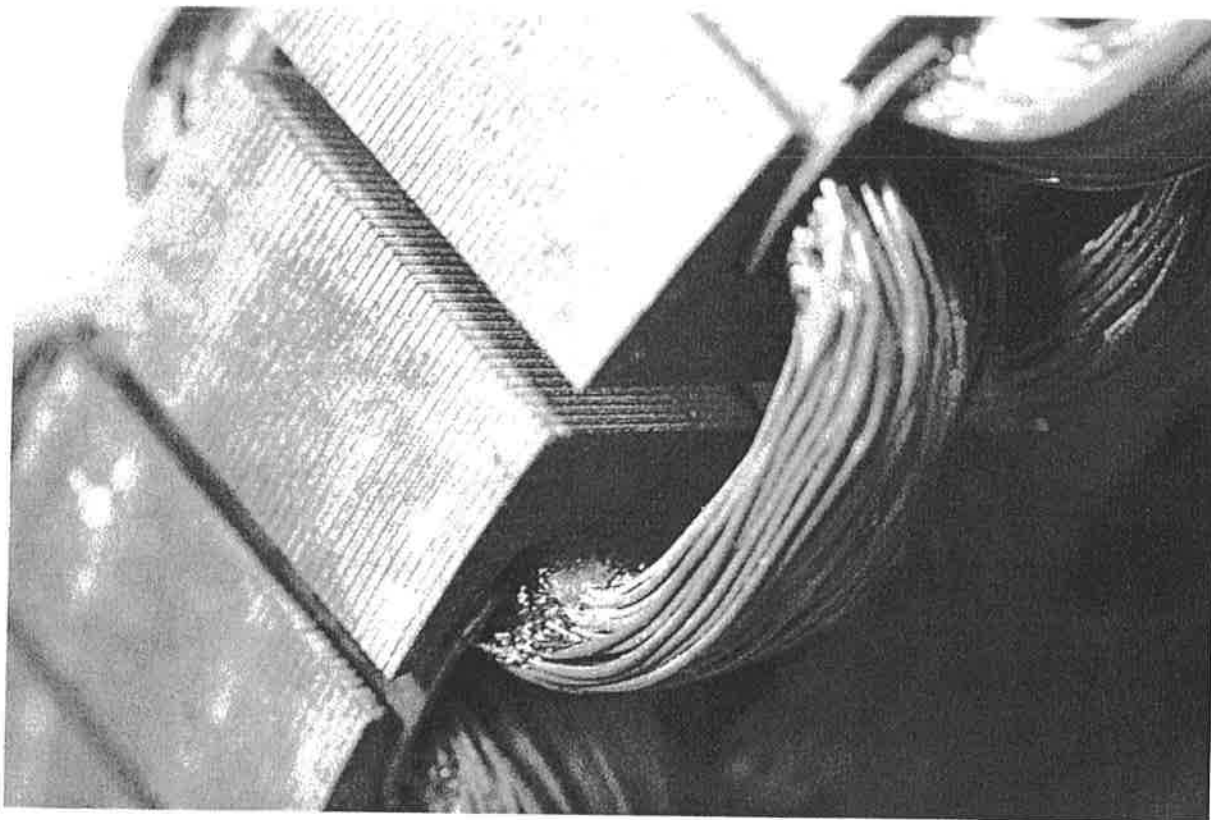
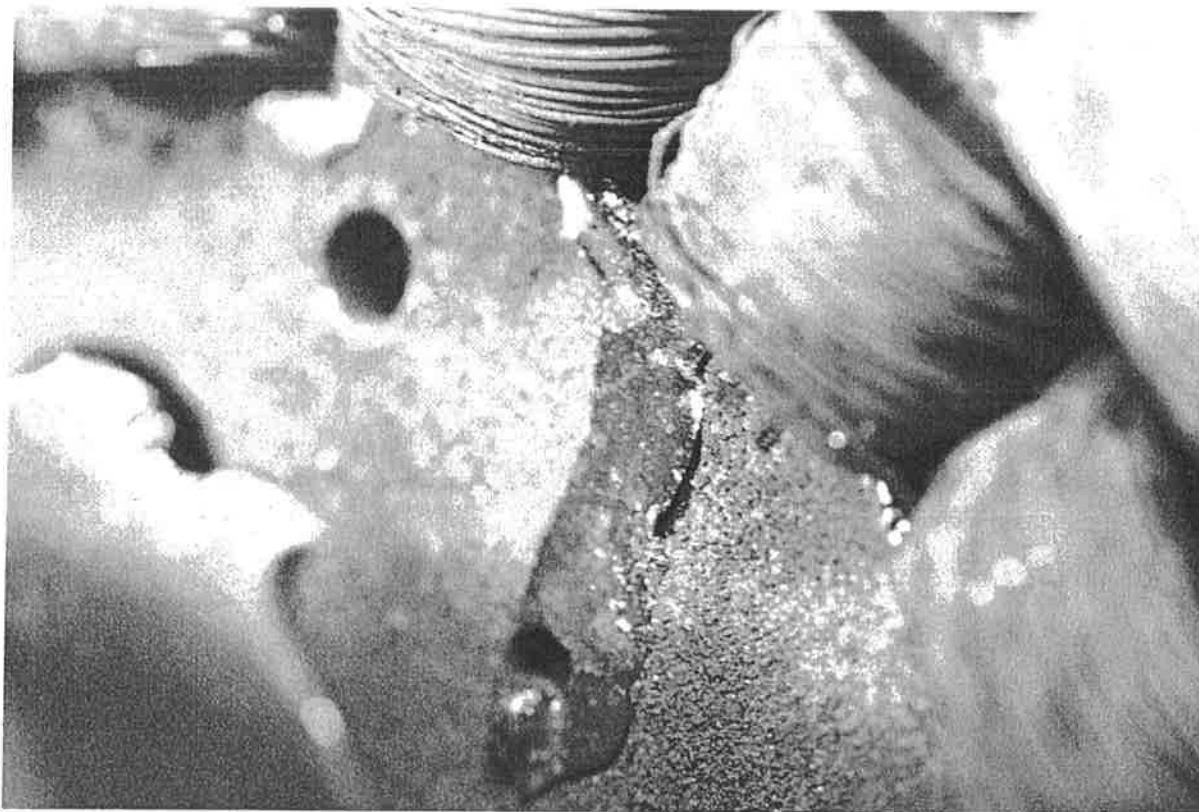
7. Damage to the windings lessens with greater distance from the laminated core.
